Team 3 consisted of Tim and Martha Cassel, Bryan Singer, Jim and Ethan Wilmot, Denise McKinney, and yours truly. Dean Grothe generously spent the day working with our team.

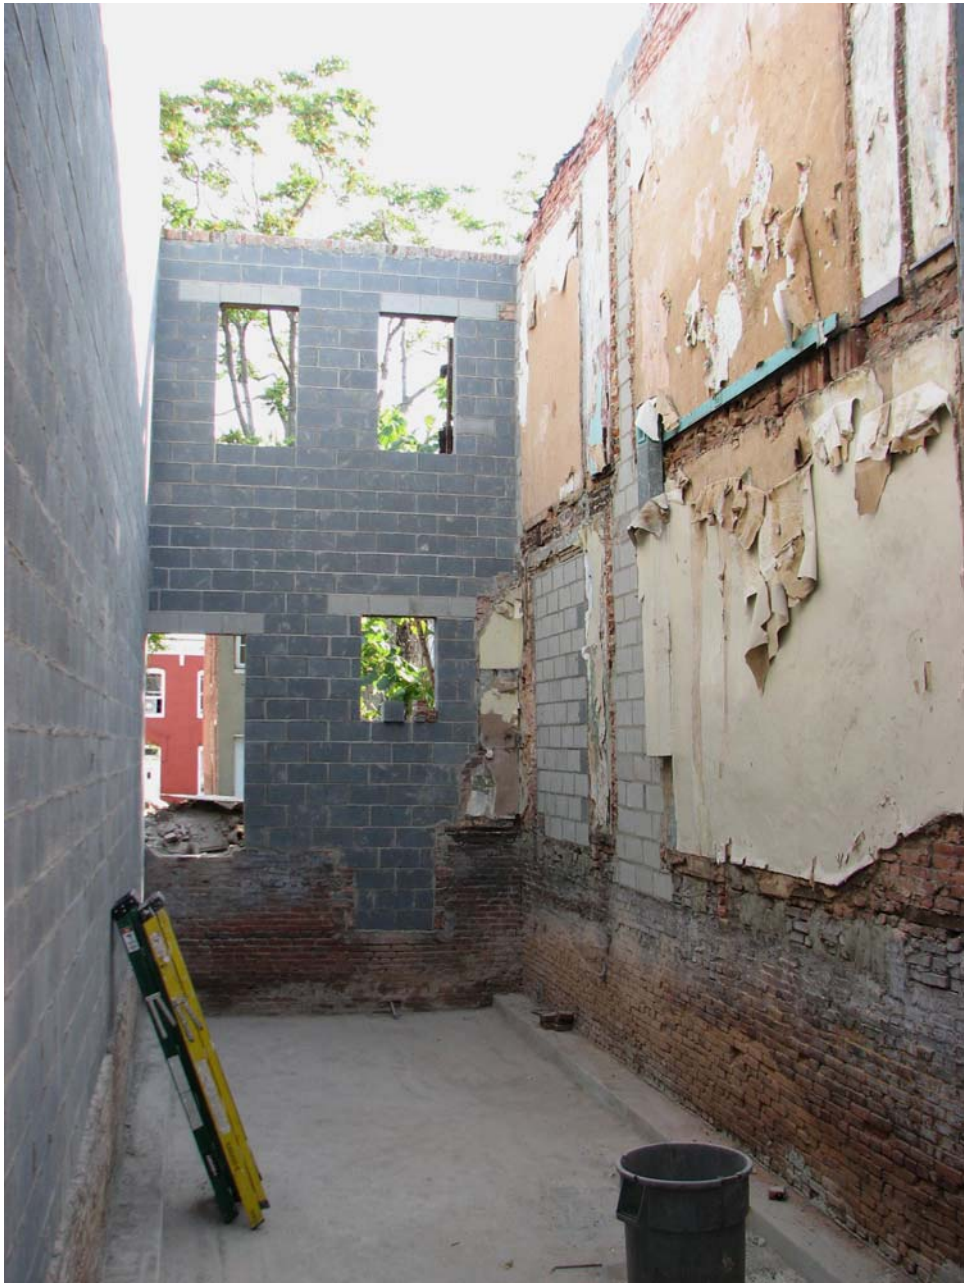
In addition, the new footers on which the basement framing rests aren't level front-to-back and the left footer isn't consistently level with the right footer. We first laid a framing level along the footer on the left side, and it looked straight, but once we'd cut the studs all to the same length and set the wall in place, it became apparent that there were areas where the concrete had set at different heights. I imagine if we ignored this problem and went ahead with the joists and subflooring, it wouldn't be too apparent that the floor wasn't level, but it would be better if the top plate of the left wall were shimmed. I've attached a photo to illustrate where the shimming may be needed.

When we began the right wall, we tried cutting each stud to a different length to accommodate the variations in the footer, but I think we were only partially successful, so shimming may be required on the right wall as well. I suspect the best way to proceed may be to build the right wall as level as possible, then insert shims while installing the joists, depending on how level each joist is. Hope this makes sense.
